MZEC 2011 FATAL INCIDENTS

MZEC 2011 INCIDENTS

JBBA INCIDENT

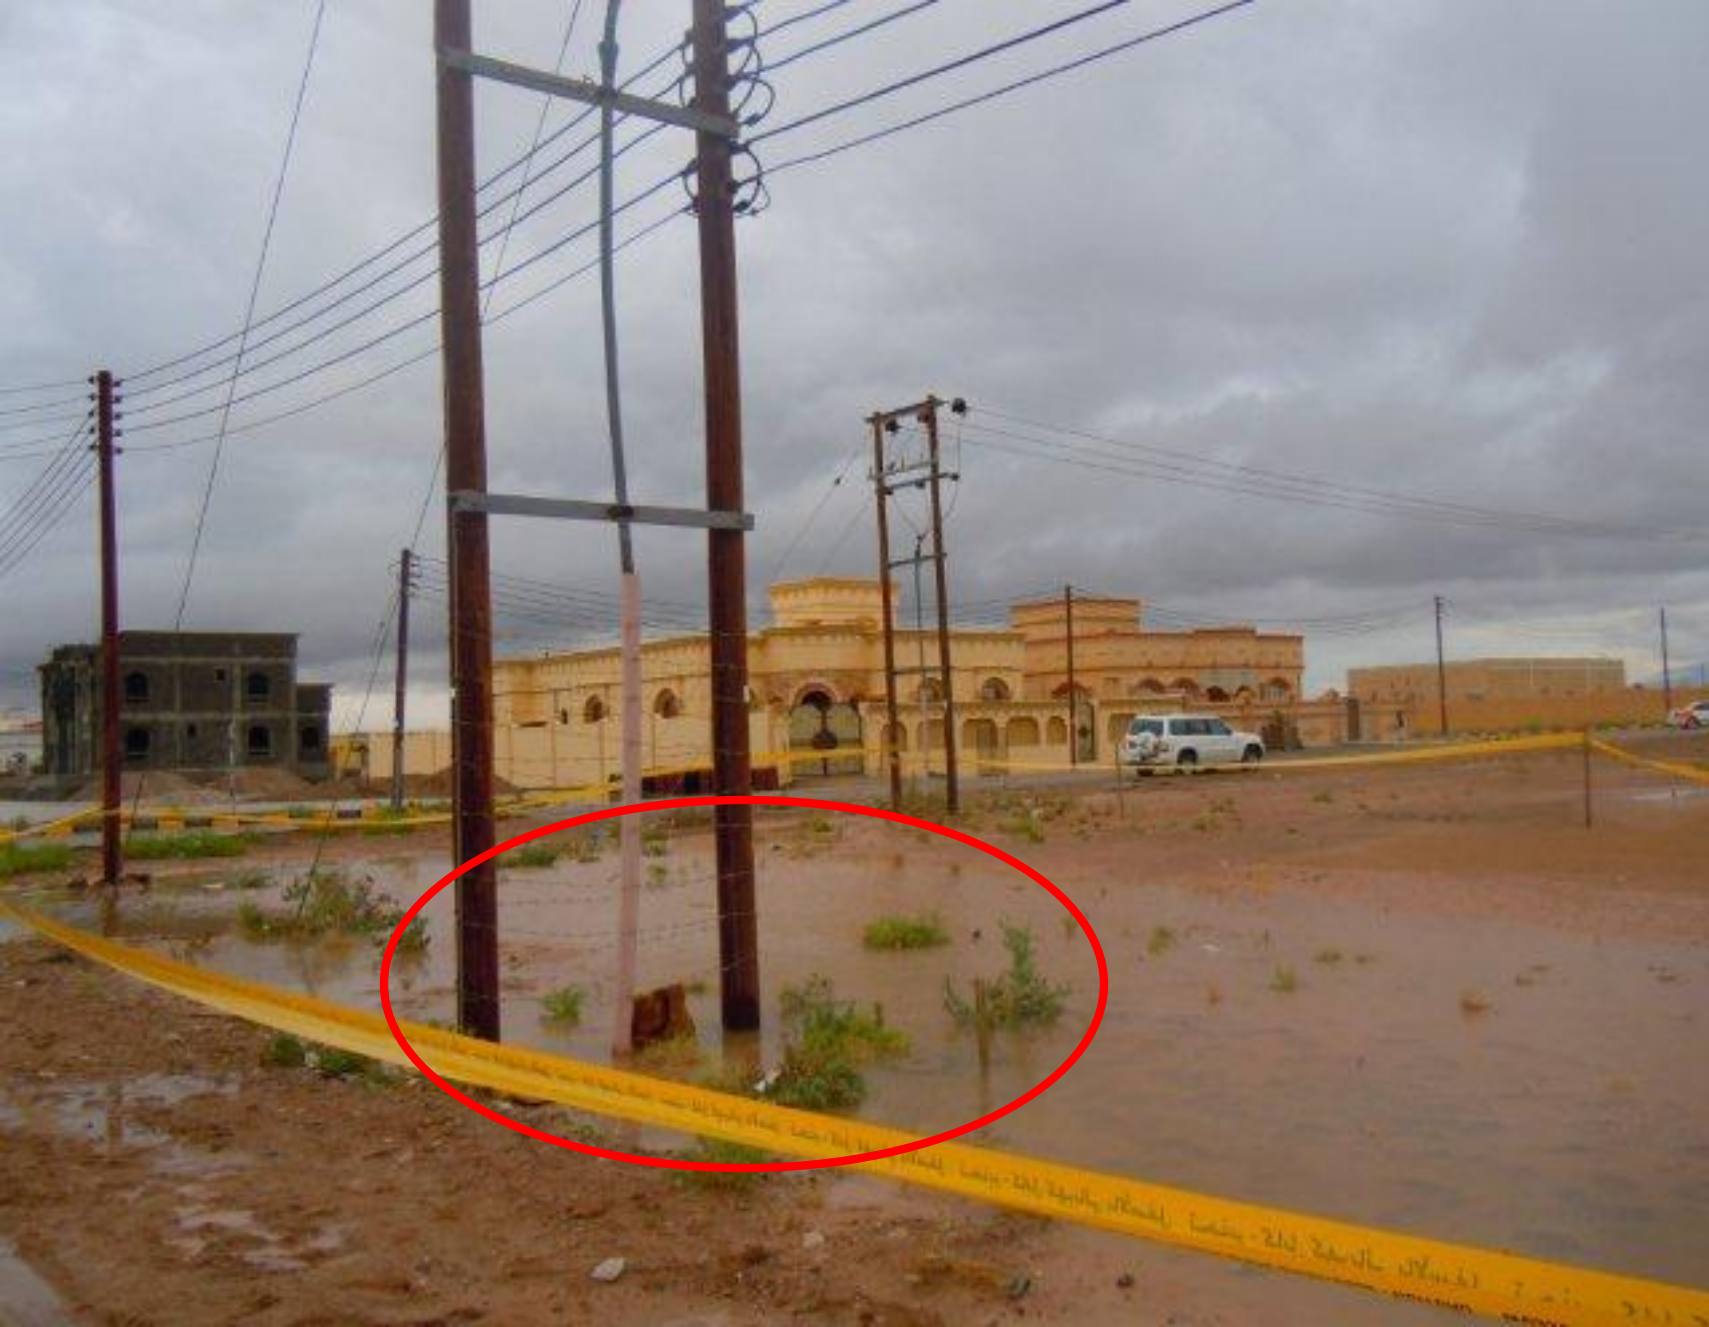
On 1 November 2011, a severe death electrical shock accident occurred for three persons at JBBA District during rainy storm, when a boy 12 years old was walking near by HT poles which was surrounded by a pool of water, he received an electrical shock and died. Then, a teenager 16 years old (his brother) was trying to survive him, he also received electrical shock and fell down, as well as, for young man died while he tried to succor the victims.

Point Of Electrocution

- ❖ Electrocution by Low voltage leakage current through water pool.

- ❖ Lack of understanding of the electrical hazards.
- ❖ Poor design of distribution networks.
- ❖ Weather condition.

| Detail | Target Date |
|---|---|
| Convert all parts of LV overhead lines to underground cable which are connected to (11&33) kV overhead Lines, Lighting Arrester, ABS, Cables, Fuses,...etc) | April 2012 |
| Prohibit LV extensions to be connected along with (11&33) kV network for either new project or premises extensions. | Starting from 27/11/2011 |
| Earth value must be checked for all new service connection and projects before energization. | Starting from 27/11/2011 |

| Detail | Target Date |
|--|---|
| Update the design of ground mounted transformer and Mini feeder Pillar to be raised from the ground level to avoid the floods and pools during rain. | After approving the standards |

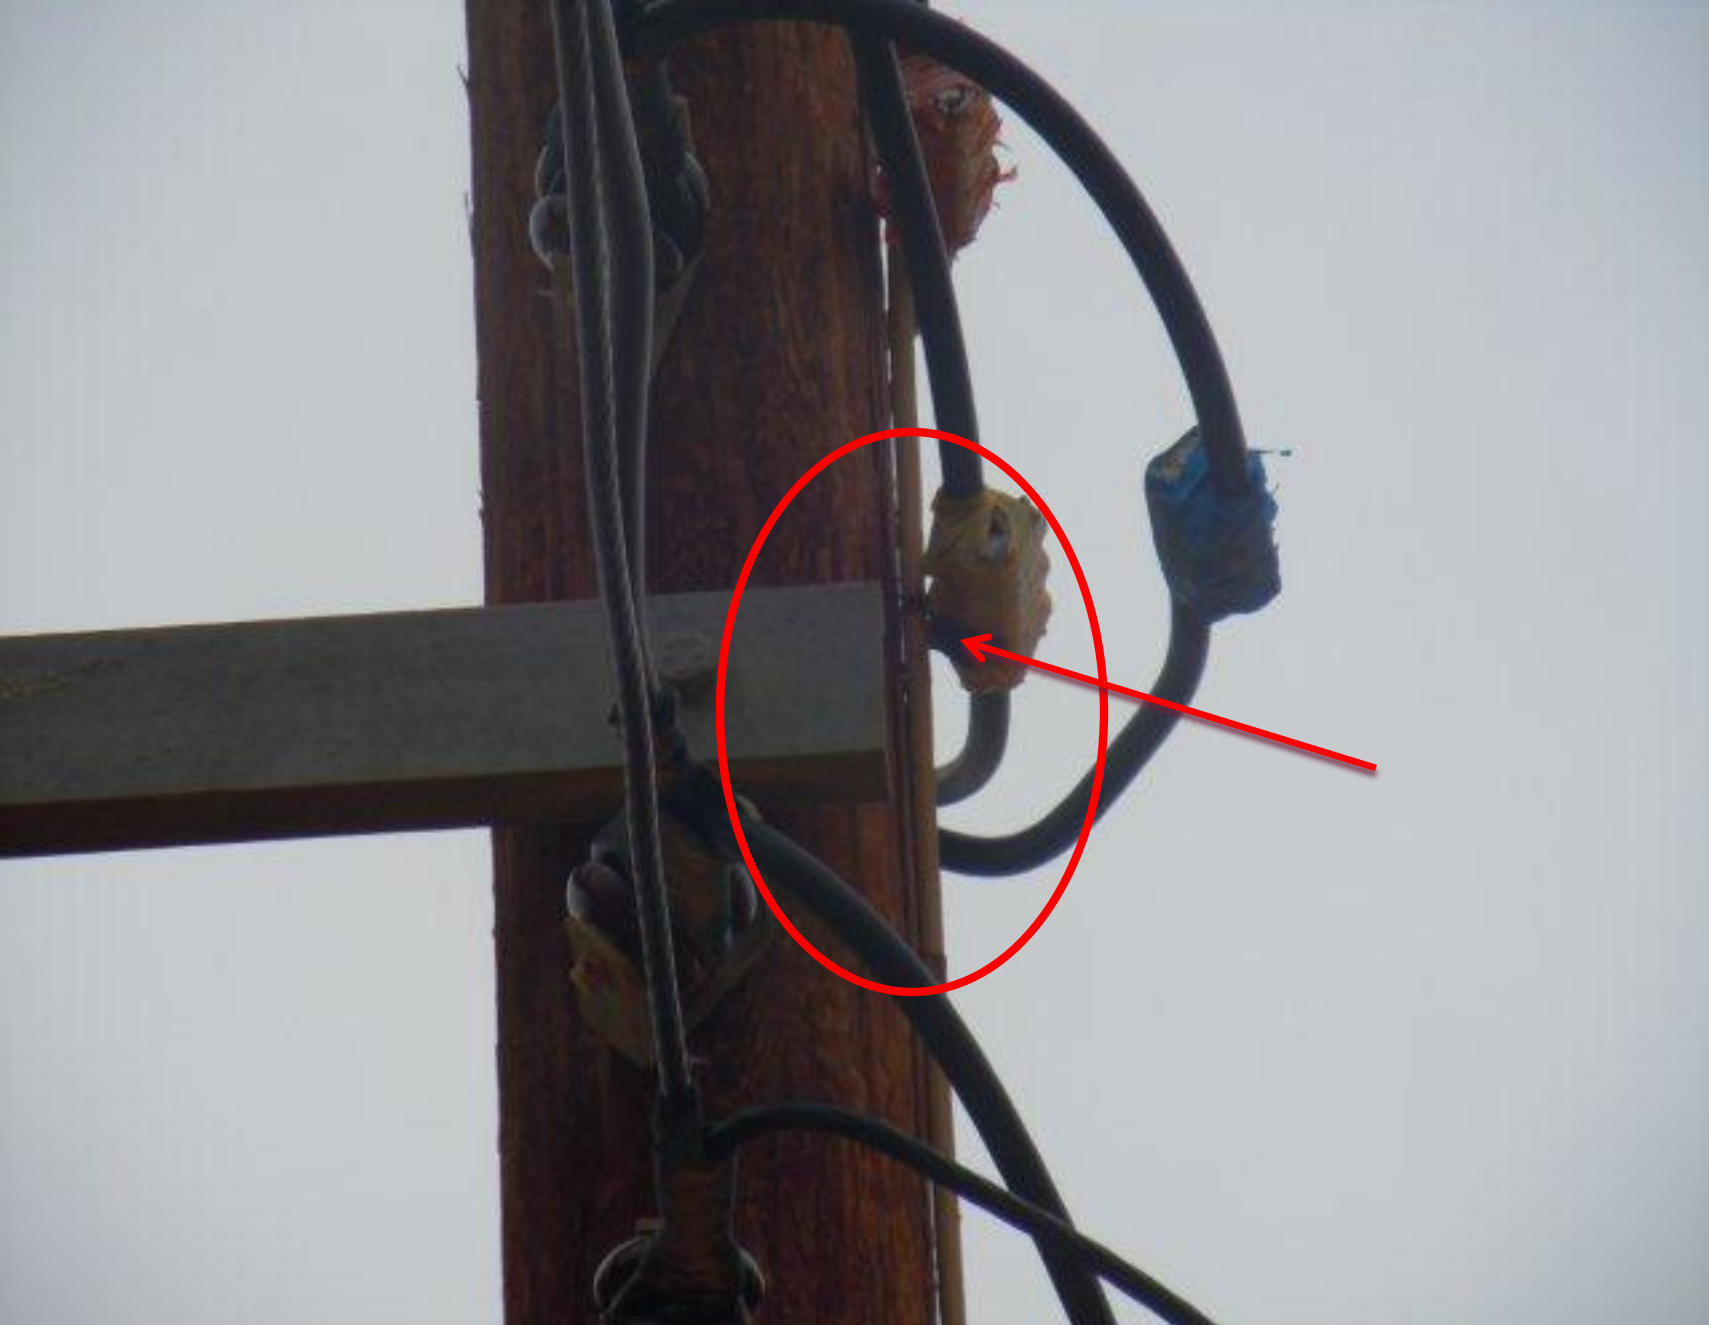
Point of Electrical Leakage Current

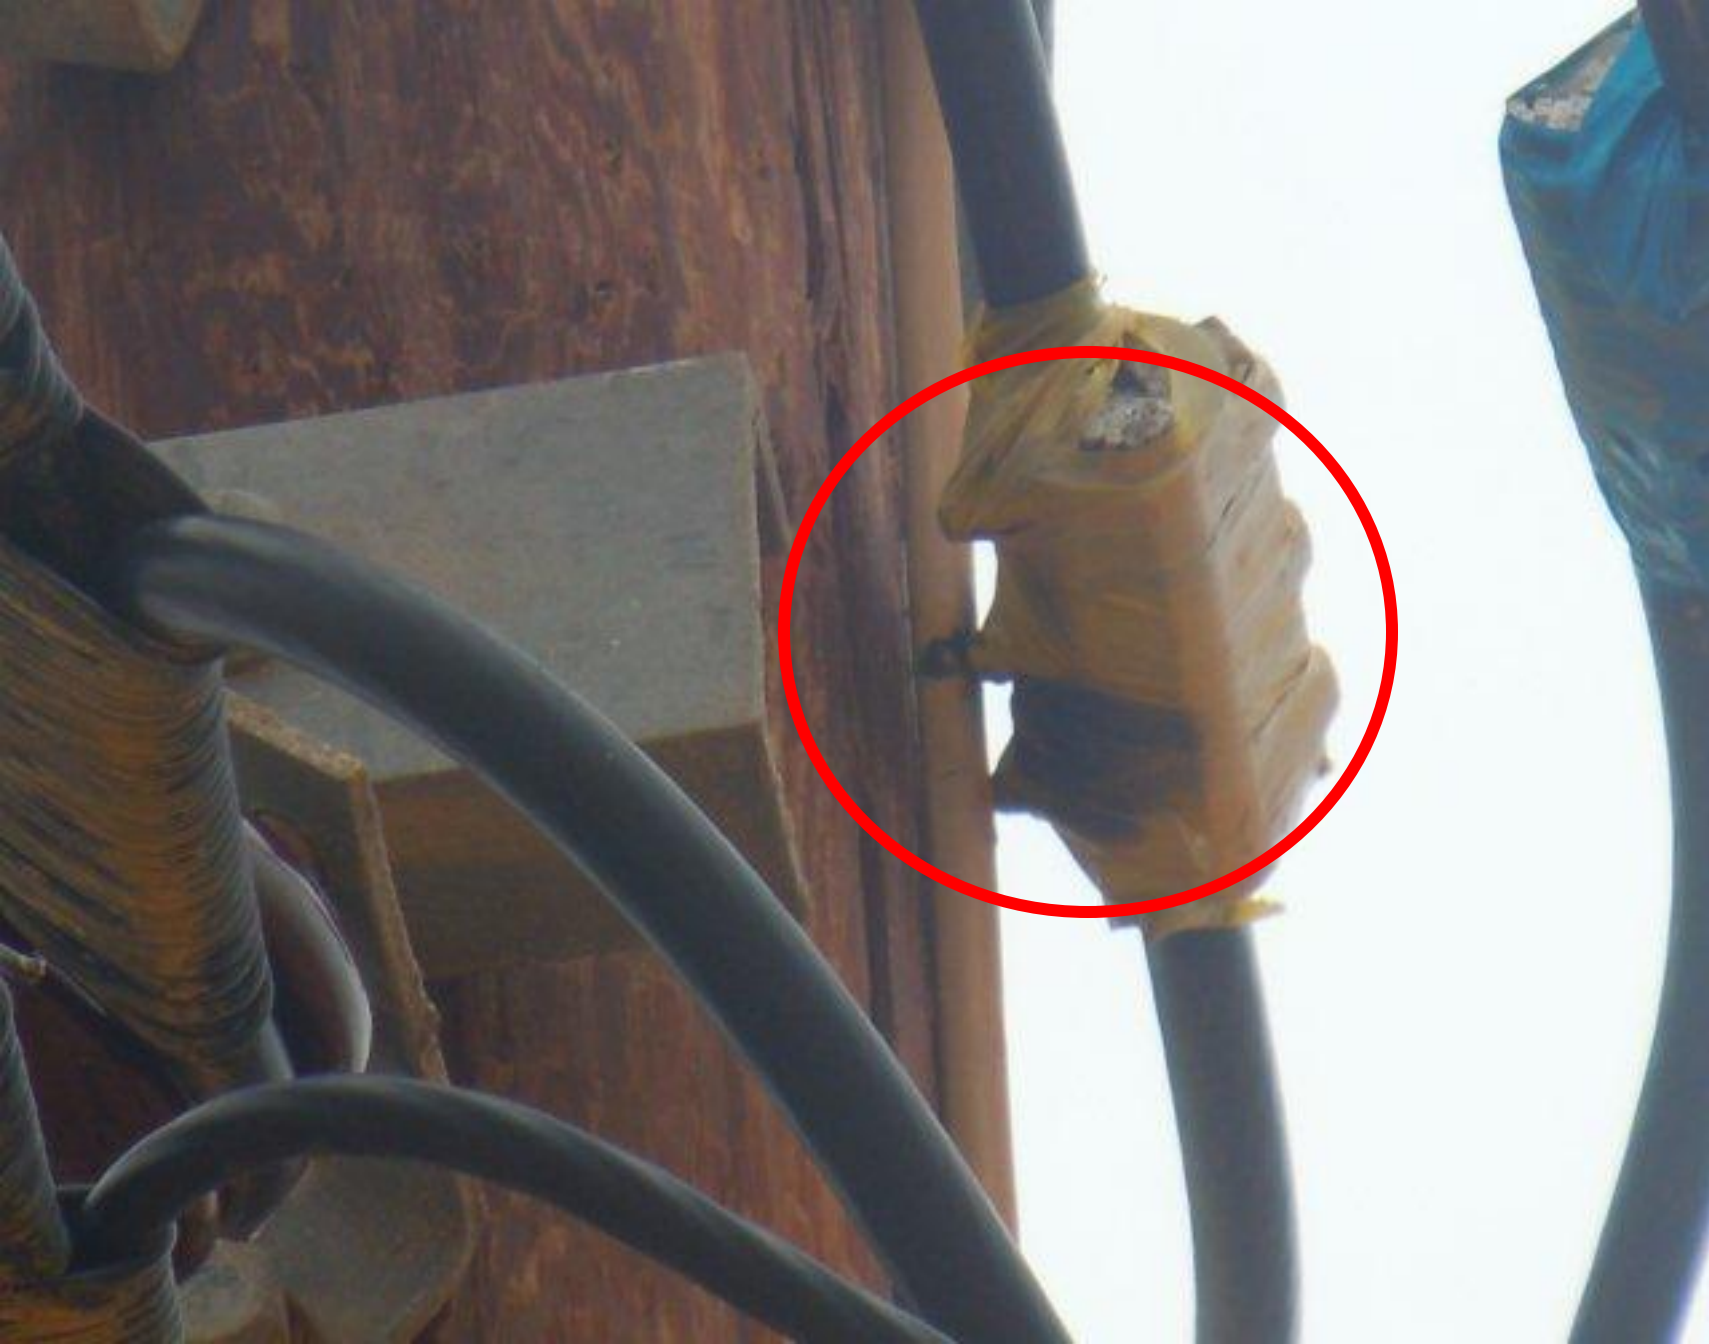
Point Of electrical Flashover

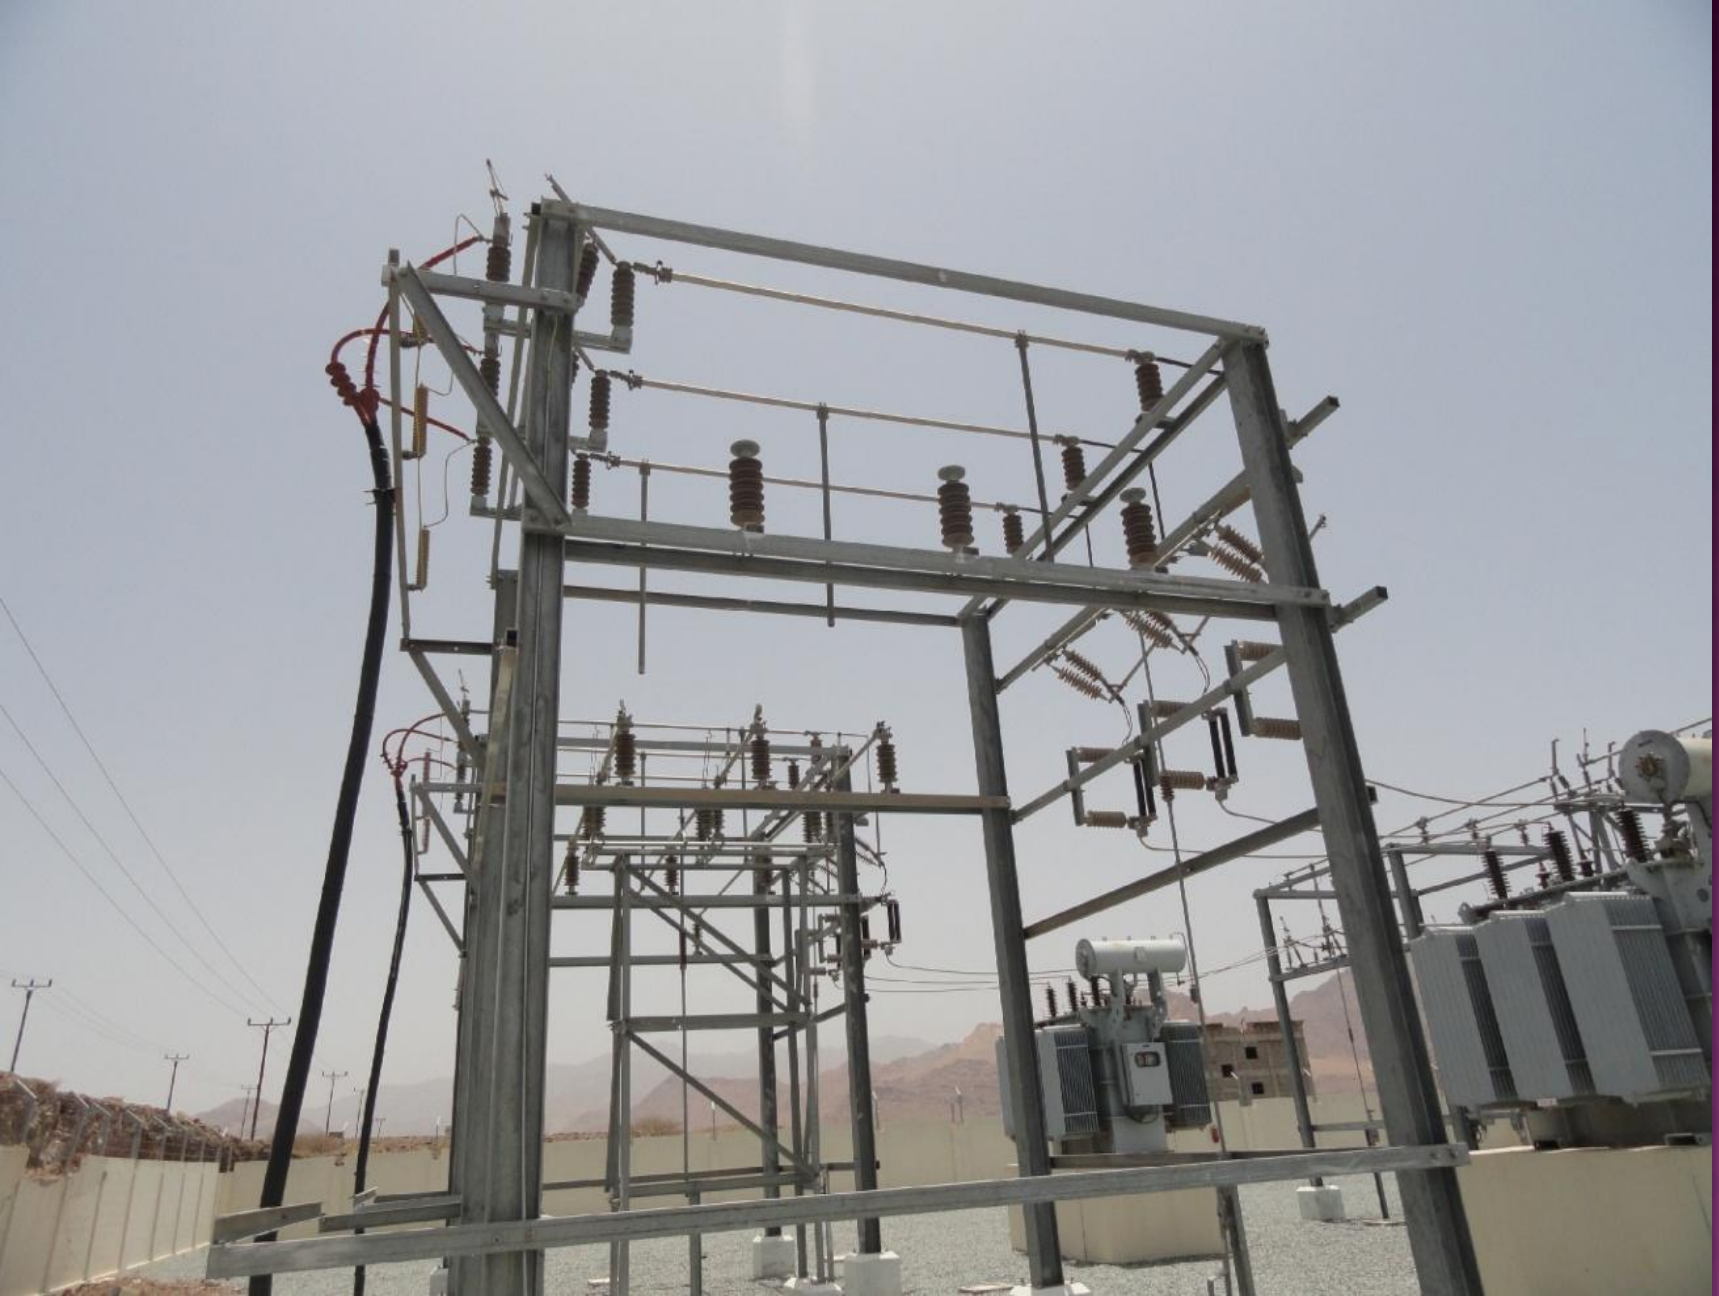
Substation Gantry

The team was used to record 33 KV load of primary out door substations in Sumail district. After the task was completed, they decided to move for steeling (33 & 11) KV busbars tubes from Saih Al Ahmar primary substation gantry. While the helper moving down towards the ground, he failed to ensure safety clearance distance and immediately received a severe electric shock with burns, as well as, fall from height.

| Detail | Target Date |
|--|---|
| Limit the admittance to primary substation for Authorized person only (contractor, MZEC, Visitor) | 2012 |

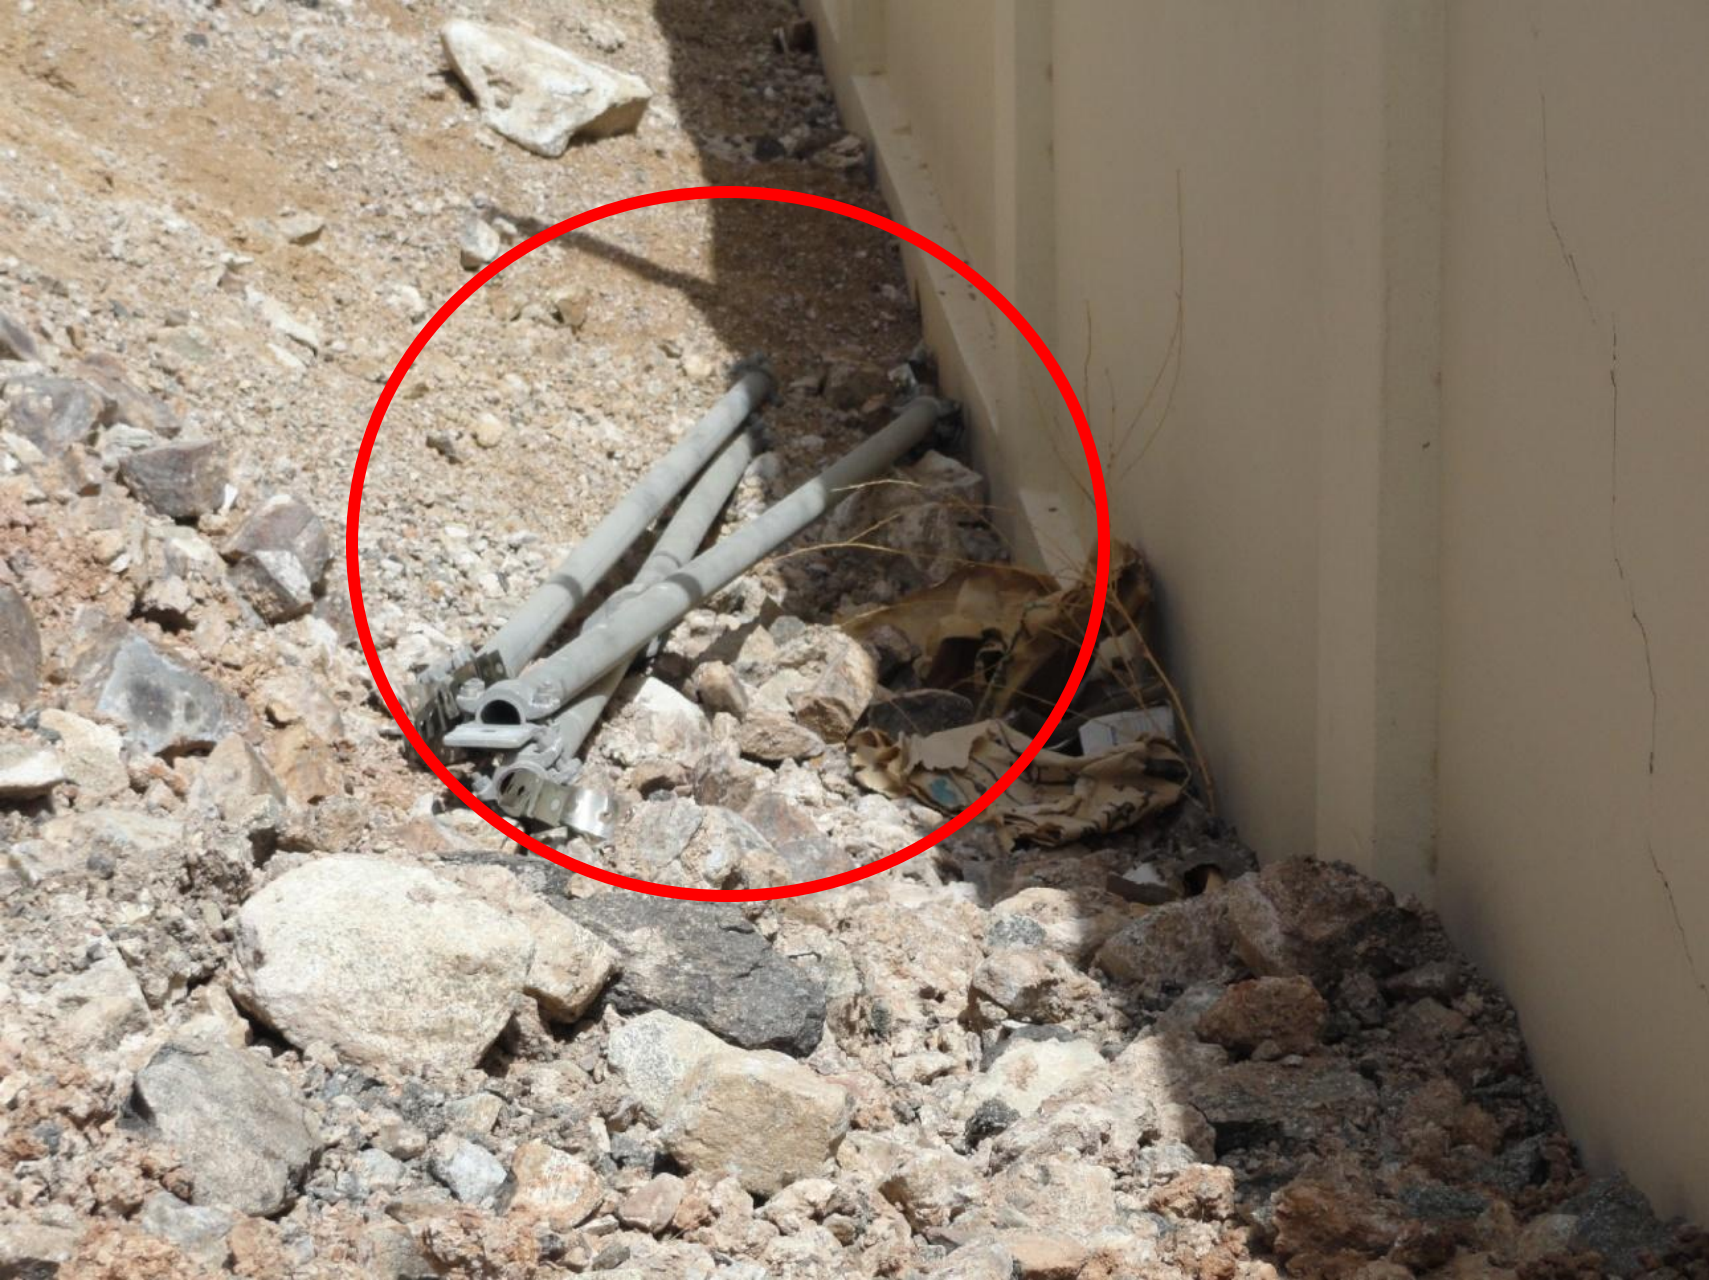
Dismantled 33 KV Busbars Tubes

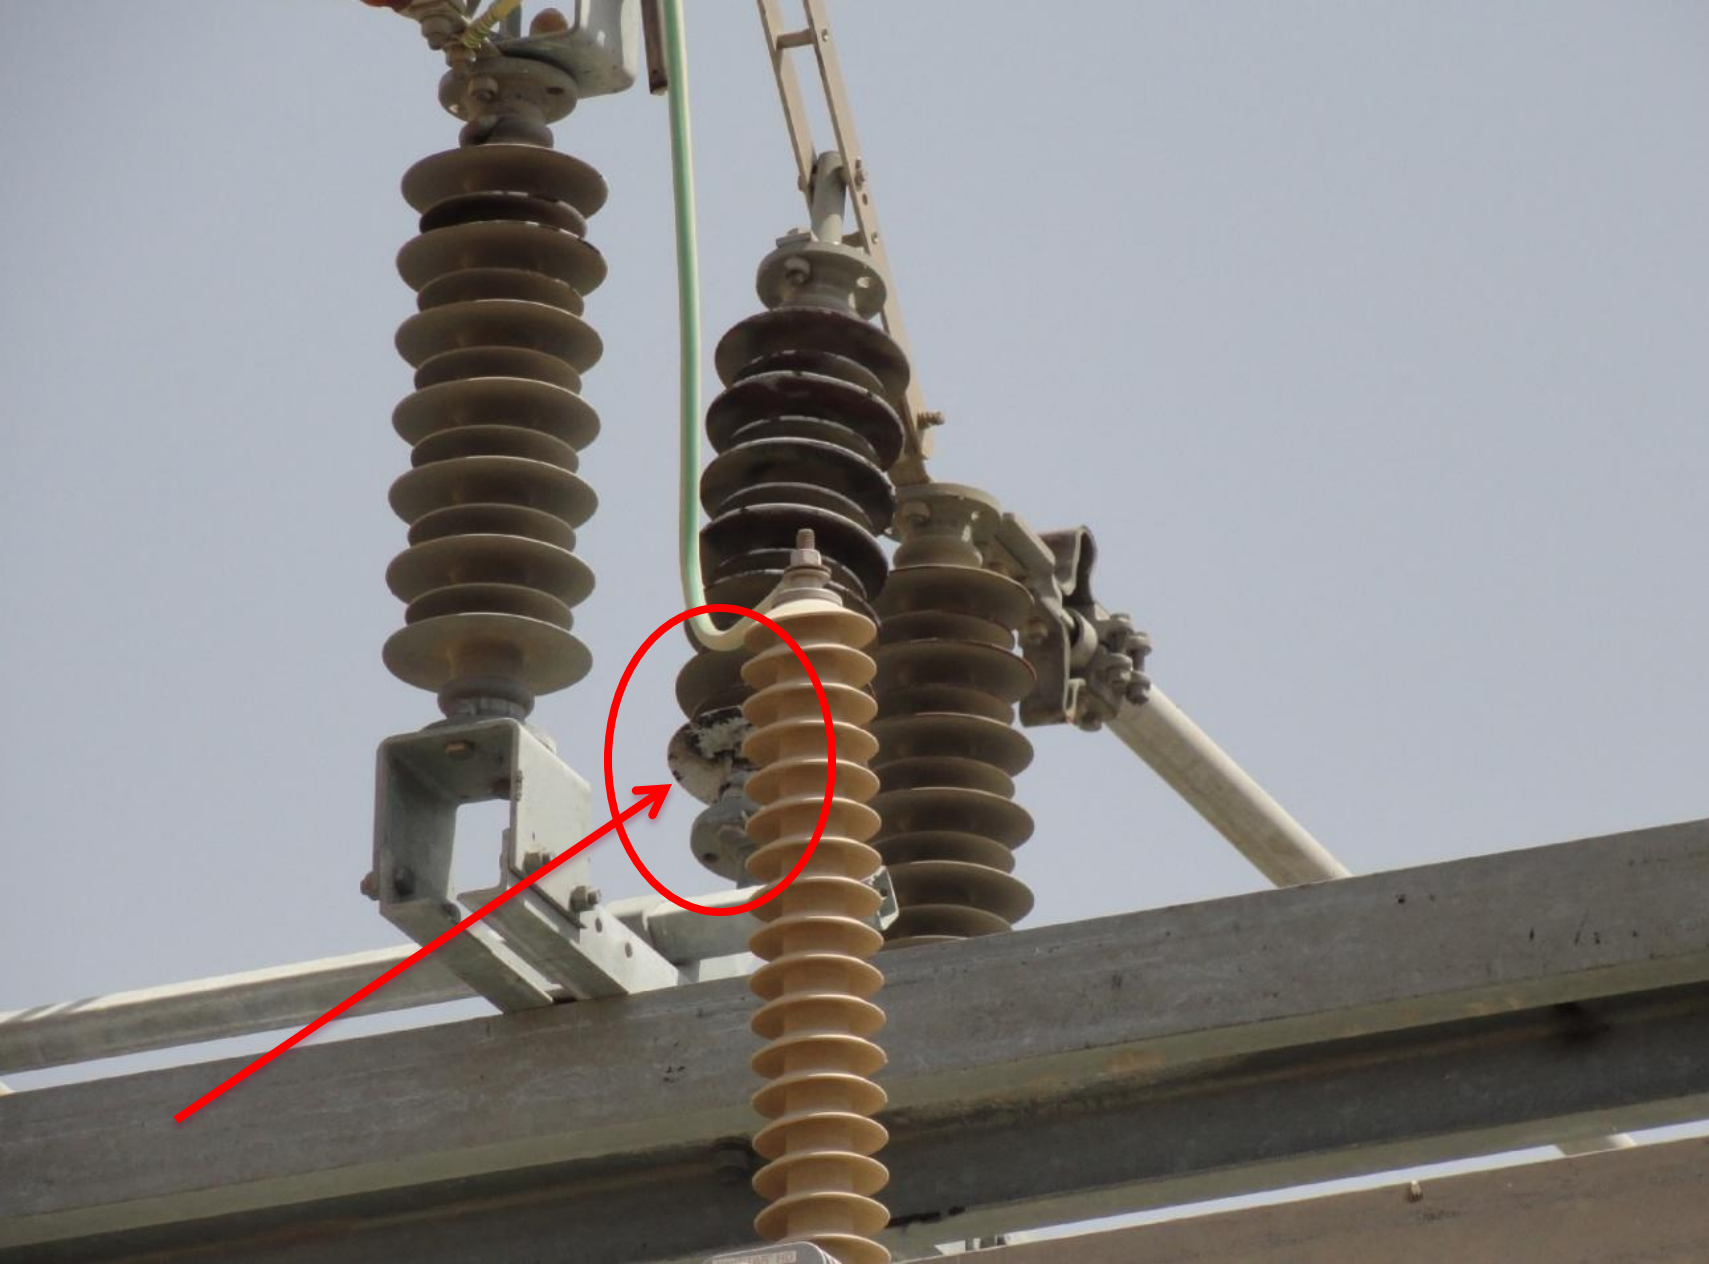
Point Of Electrocution

- ❖ Direct contact with 33 kV Live parts.

- ❖ Lack of electrical hazards understanding.
- ❖ Lack of supervision & training .
- ❖ Not wearing personal protective equipment (PPE).
- ❖ Removal of assets locks and guards.

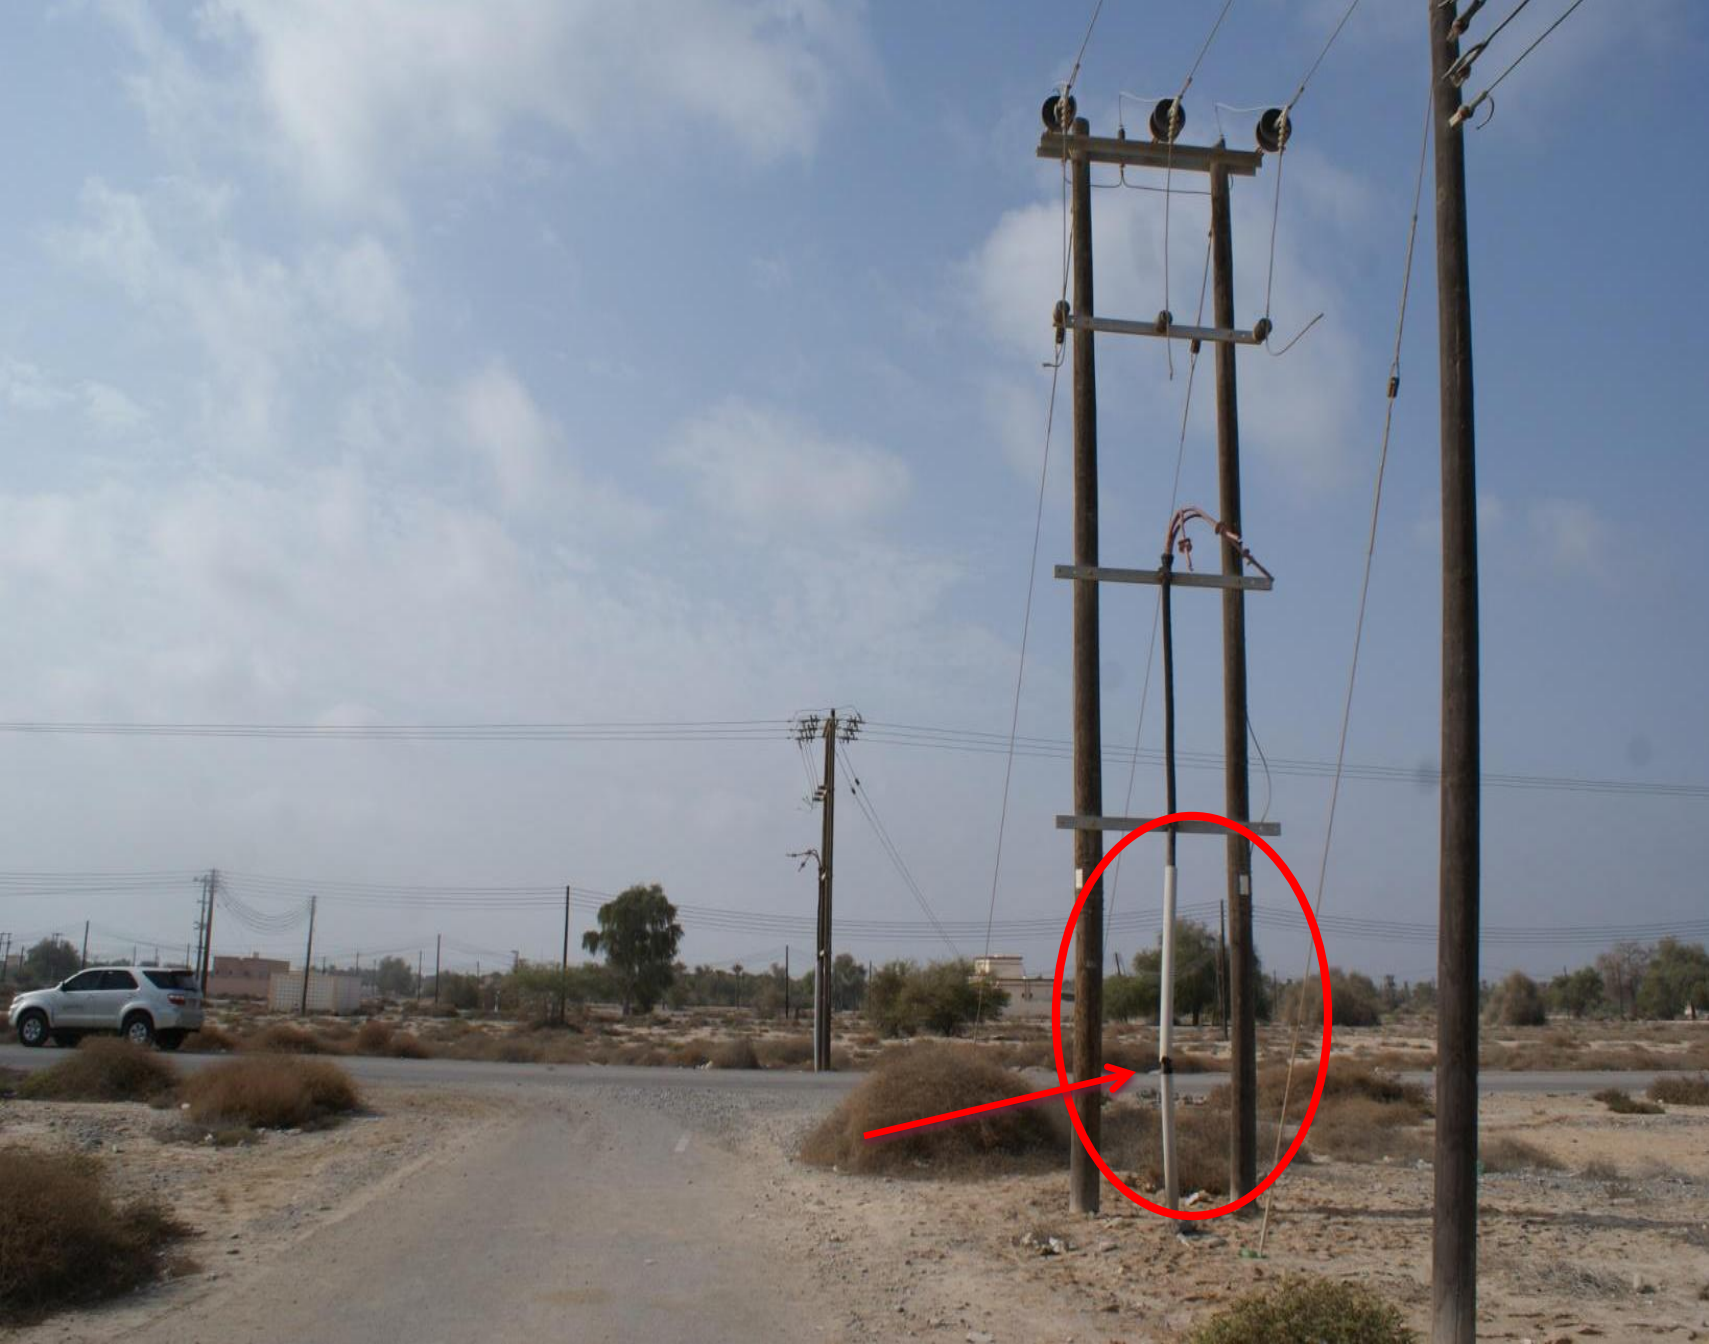
Accident Location

A severe death accident has occurred on Saturday dated on 10/09/2011 at Barka district for a young man. The underlying cause of the death is electrocution by high voltage cable. There were two men who tried to dismantle a short part from 11KV cable by using a metal hacksaw for purpose of cutting the cable.

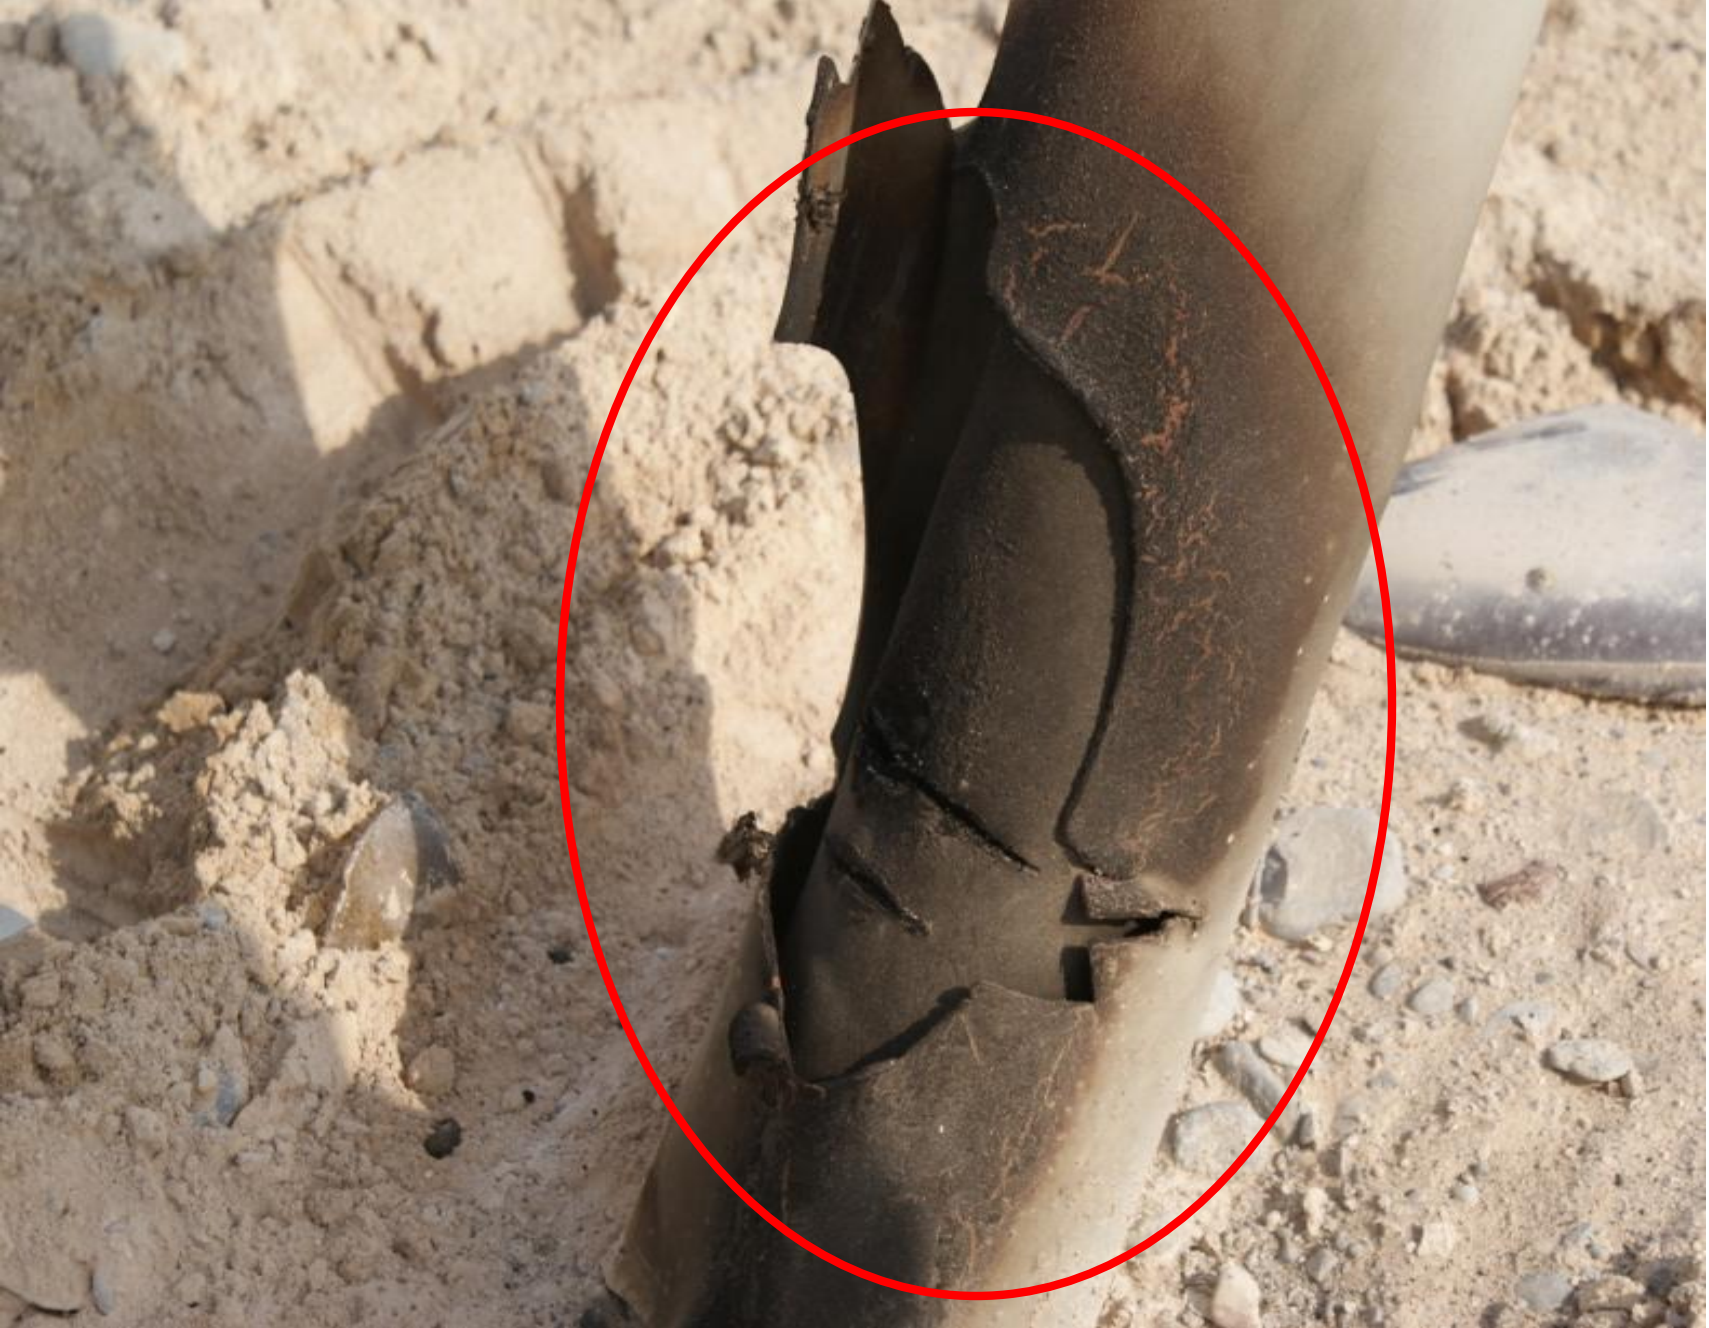
Point Of Electrocution

- ❖ Electrocution by high voltage (11 kV) energized cable.

- ❖ Lack of understanding of electrical network connections.
- ❖ Lack of understanding of electrical Hazards.
- ❖ Using non-insulated material for cutting the cable.
